KG5 Oval Glenorchy TAS

Issued April 2010

Interchange & run on areas

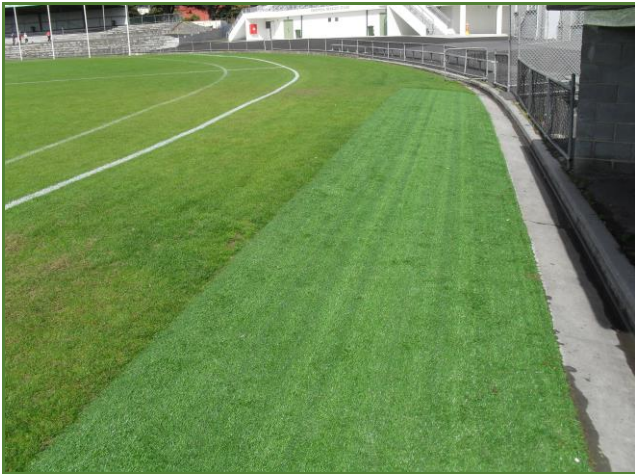
Each year after a few weeks into the football season the **Glenorchy City Council's 'KG5 Oval'** experiences an *enormous amount of 'chopping up'* in the high traffic areas which never gets the chance to repair itself & jeopardizes players safety.

The interchange & run-on areas are the first affected which also makes it difficult for players to get 'rub-downs' without getting muddy. At this time the council didn't have any solution for the problem and continued to maintain the areas as they always had which was expensive and substandard. Gecko was called in to view the ground and proposed a surface solution that would eliminate the problem.

Gecko provided a solution by installing a 'soft-fall' pad (conforming to the Australian Critical Fall Height standard AS4422:1996) which is contained & secured by Gecko's Safety Logs. The surface is then finished off with Gecko's Premium Synthetic Grass which has a 10 year guarantee and provides a natural look & feels great. This system is completely safe to a footballer and eliminates any dirty & muddy areas.

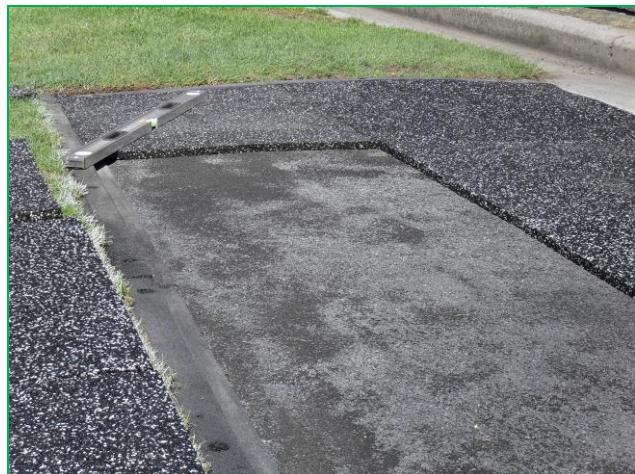
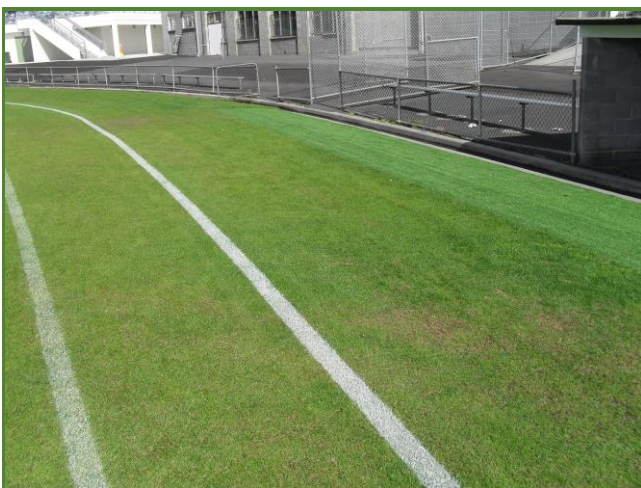
"We had been looking to do something like this for the last couple of years, but didn't really know where to go. Gecko turned up with a solution that has fixed the problem areas mainly the interchange boxes which are always wet, have high traffic & are hard to repair because they're always in the shade. Gecko's involvement & communication has been great and when we need anything its no problem With this success we have just employed them to do the same areas on our soccer field".

Since completing this project the surface has been a great success and Glenorchy City Council has earmarked other grounds to install Gecko's Soft-fall System.
